## Constructed Wetland Options in the Upper Waituna Catchment

Prepared for Dairy NZ

June 2014

NIWA Client Report No: HAM2014-069  
Report date: June 2014  
NIWA Project: DNZ14207

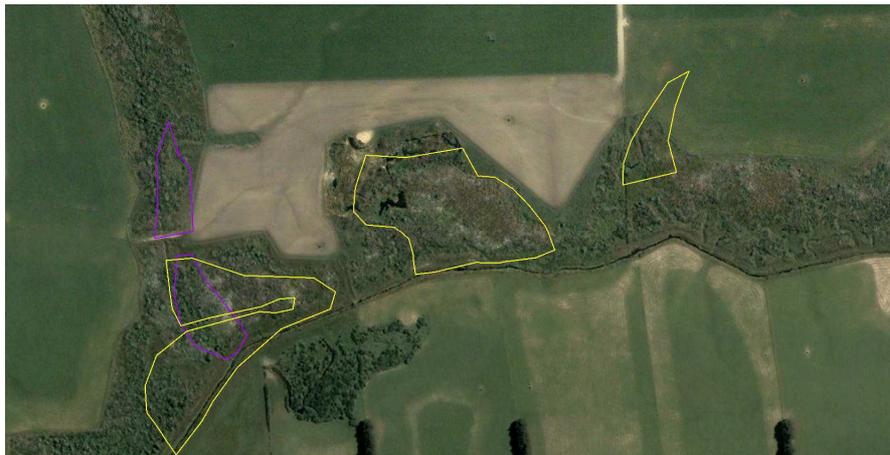
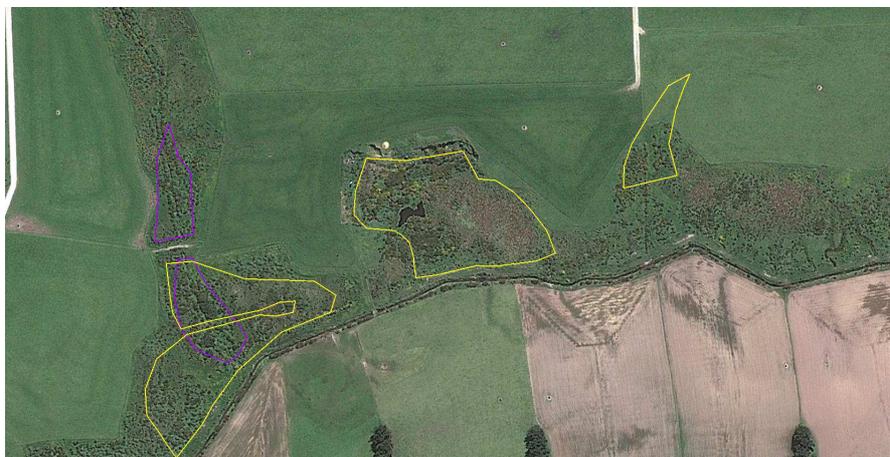
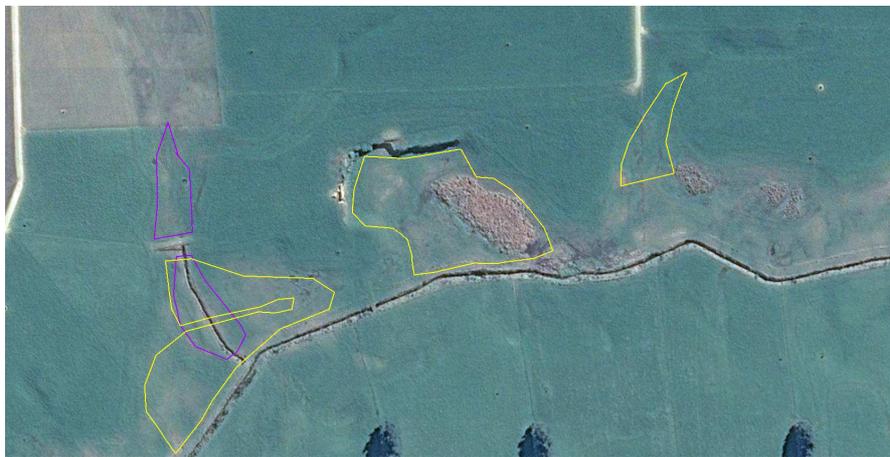
**Figure 3-1: Location 1: Example of recent wetland drainage in the upper Waituna Catchment.**  
Prospective sites investigated for wetland construction during the current project are marked.

A common issue we encountered during our investigations in the upper Waituna catchment was that farmers had recently spent substantial amounts of money draining the very areas where wetland construction was most feasible (see examples; Figure 3-1 and Figure 3-2). In many cases these had been the last and most difficult low-lying areas to drain and farmers understandably were reticent to see these hard-won areas converted back into wetland, and forego the expected payback on their investment. So, although it would still be practically feasible to build wetlands in these areas, there would likely be significant antipathy from farmers, creating a significant hurdle to future application of constructed wetlands in such areas across the catchment. We estimate that this may affect in the vicinity of half of all potential wetland sites in the areas of the upper Waituna Catchment where our investigations were focussed. This emphasises the need for early intervention before farmers have invested large sums of money into wetland drainage, as well as the need to foster greater awareness of the potential value of natural wetlands for contaminant attenuation of intercepted run-off. The cost of re-constructing such wetland areas is significant, as becomes evident below (see Section 5.3).

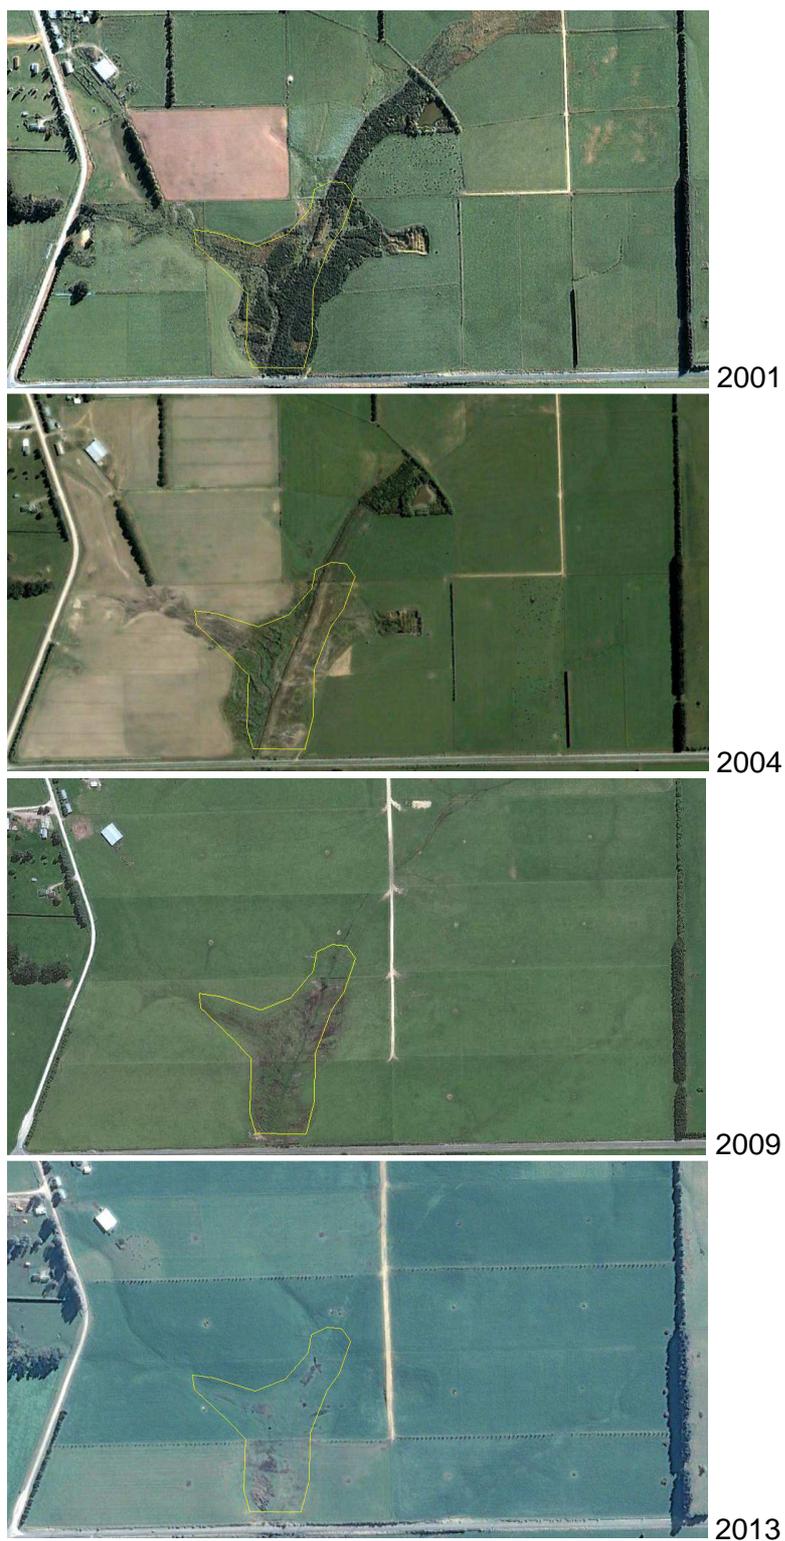
**Figure 3-2: Location 2: Example of recent wetland drainage in the upper Waituna Catchment.** Prospective sites for wetland construction investigated in the present study are marked. Various episodes of drainage works are visible in 2003 (not shown), 2004 and 2009 views.

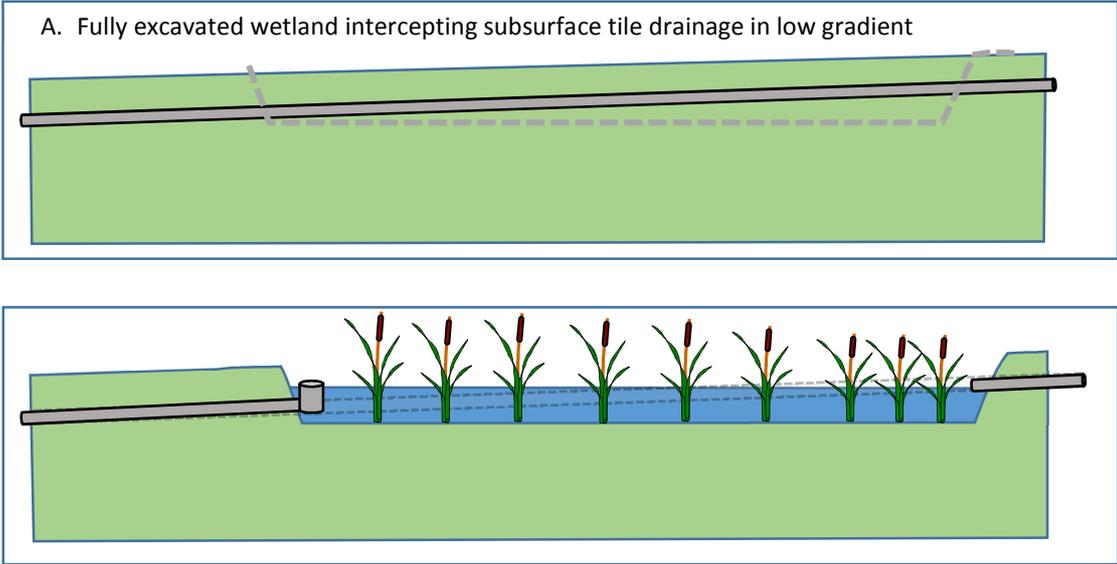
**Figure 4-1: Illustration of wetland creation in low gradient, tile-drained situations.** Note that to maintain the functioning of the upstream land areas the whole wetland needs to be excavated to below the upstream drain depth to maintain functioning of upstream drains.

Excavation of a pond at the upstream end of constructed wetlands is recommended to trap coarse sediment deposits (that would otherwise gradually fill in the wetland) where they can be mechanically removed periodically. This can also provide habitat for waterfowl and associated recreational activities. The outflow structure should preferably be designed to retain flows and slowly release them, promoting creation of a reasonably permanent wetland.

In-stream wetlands need to be built to withstand major floods, and would likely require high flow diversion channels to maintain flow passage and limit damage to the wetlands. Ideal locations for wetland construction occur where there are constrictions in valleys (reducing the size and cost of any dams required and enabling anchoring of them into firm ground) and where land surrounding the flood plain rises relatively steeply to delimit the wetland margins.

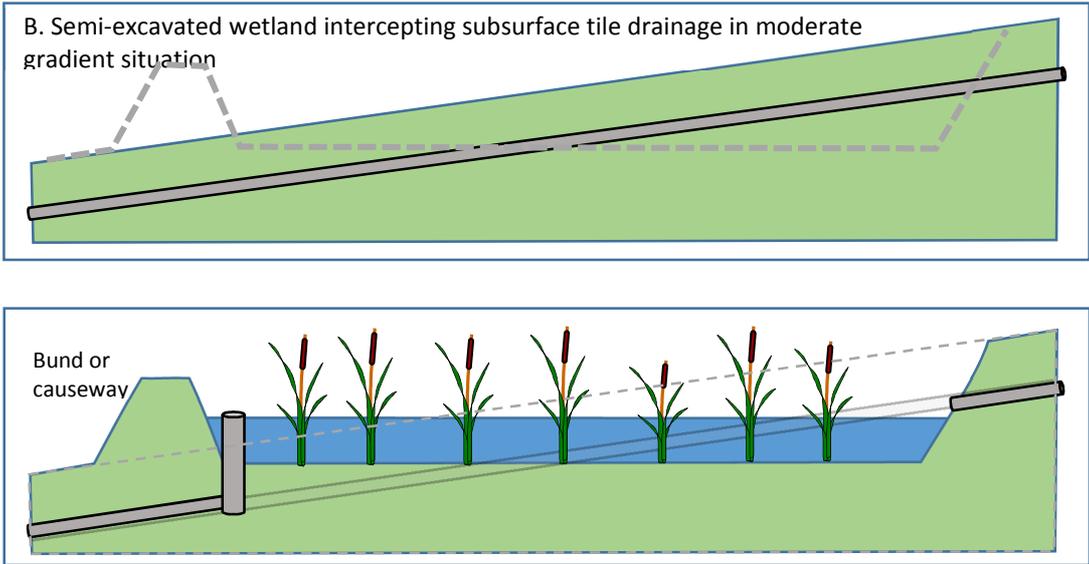
**Figure 4-2: Illustration of wetland creation in moderate gradient, tile-drained situations.** Note that in this case a bund can be used, reducing excavation requirements whilst maintain the drainage of upstream land.

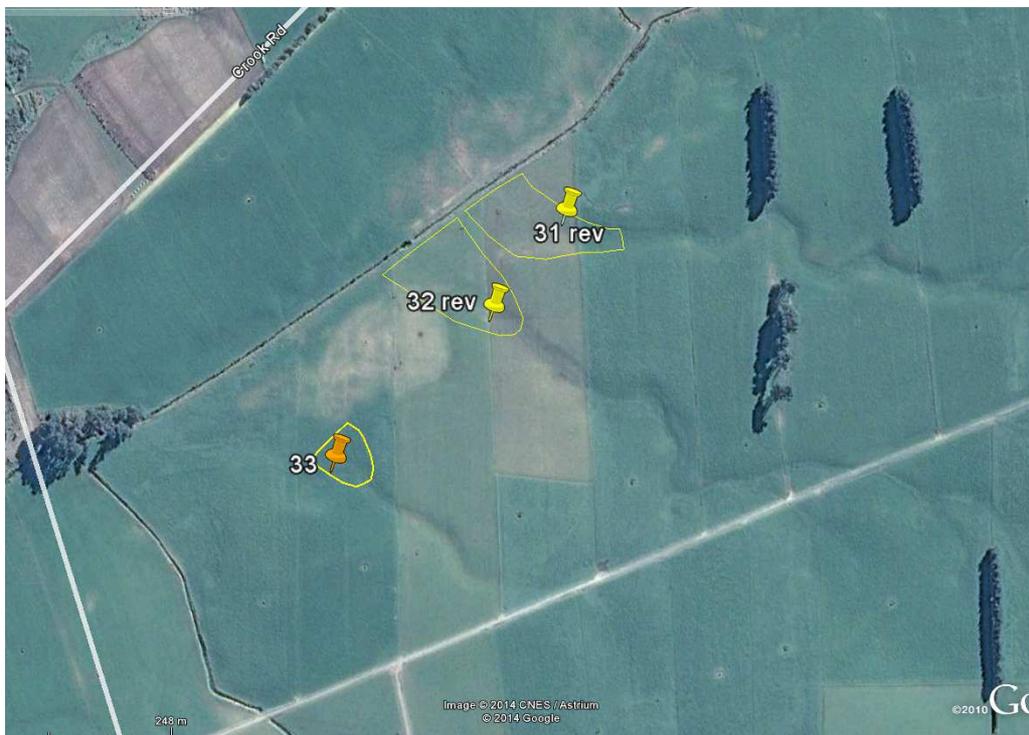
**Figure 5-1: Three prospective small wetland trial sites.** Sites 31-33 on the Anray Farm ranging in size from ~0.2 to 0.4 ha in size.

Three adjacent wetland sites (31-33; Figure 5-1) ranging in size from just under 0.2 to 0.4 were subjected to further engineering assessment. Dimensions and estimated construction and planting costs are summarised in Table 5-1. Development costs for the three wetlands ranged from \$32-64K each (~\$160-170K per hectare), which would translate to \$4.1-4.8K per ha of catchment mitigated. The two smaller wetland sites (31 and 33) provide sufficient area to construct wetlands comprising 2.5-2.8 % of their estimated drainage catchments. Site 32 had a larger catchment and only provided sufficient readily available area for construction of a wetland comprising 1.7% of its land area (below the ideal ratio for a trial). Because of the general lack of surface flows at these sites, fish passage is not expected to be a concern.

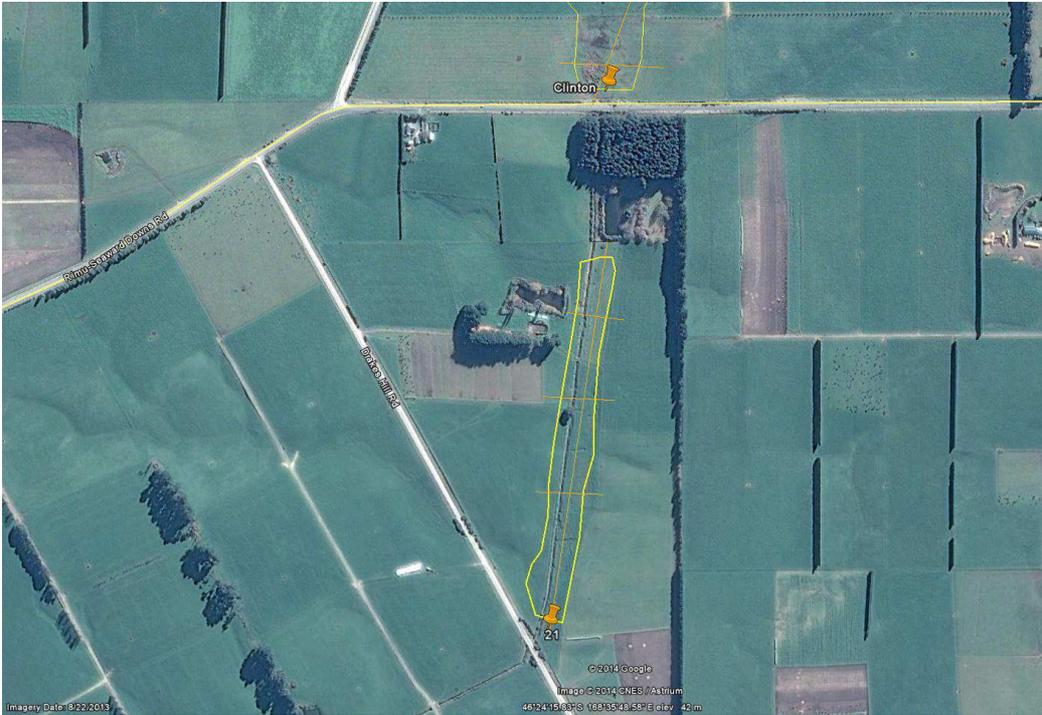
**Figure 5-2: Prospective larger wetland trial site.** A 3 ha wetland on Murray Clarke’s farm comprising 2.3 % of catchment area at Site 21.

suggesting limited fish habitat above the proposed wetland. Construction of a wetland at this site was estimated to be cheaper per hectare at just under \$100K than the other sites investigated or around \$300K in total (i.e., \$2.3K/ha of catchment mitigated).

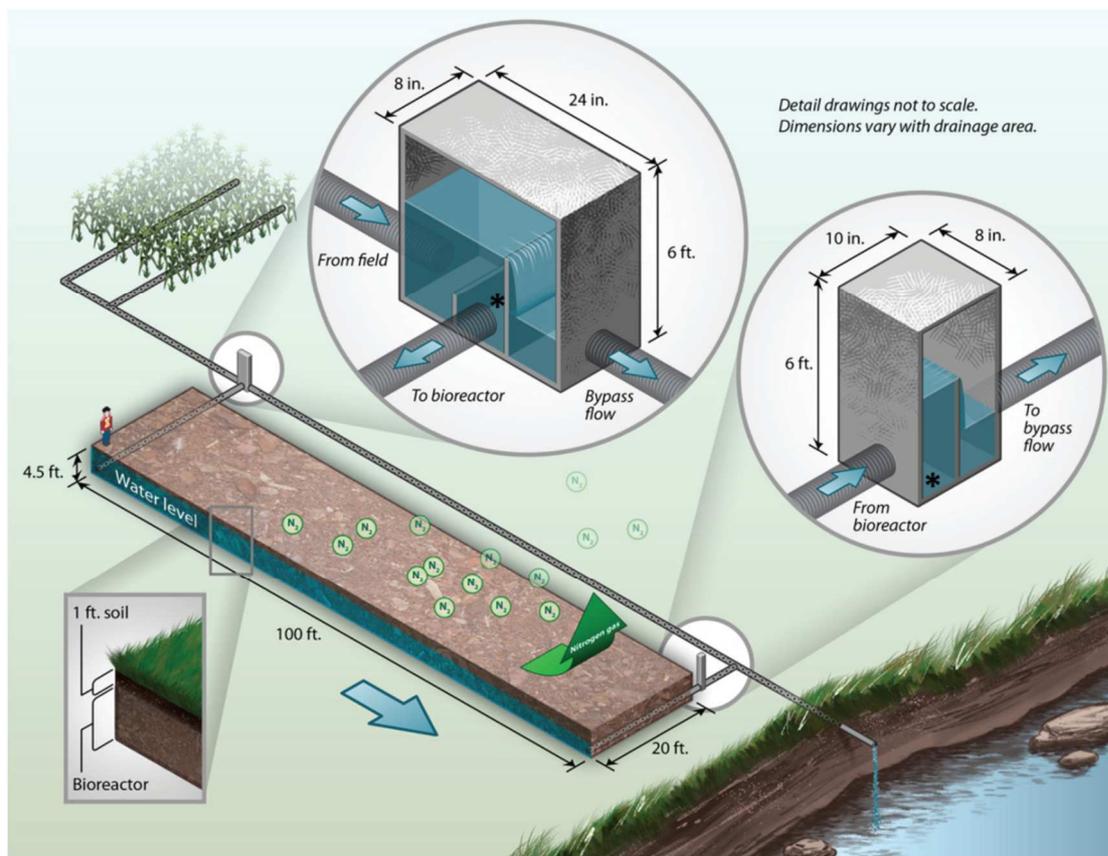
**Figure 6-1: Basic concept for wood-chip denitrification filters.** Diagram from (Christianson et al. 2012).

Denitrification filters are buried beds of woodchips (or other slow-release carbonaceous materials) constructed to intercept and filter nitrate-rich drainage (Schipper et al. 2010; Van Driel et al. 2006). In addition to supply of organic substrates, the beds must be maintained fully saturated to exclude oxygen and so promote microbial denitrification of dissolved nitrate-N to dinitrogen gas (and limit potential nitrous oxide production) (Warneke et al. 2011). Ideally some sort of weir system is required to divert flow from drainage lines into the bed and control the water level in the bed, whilst retaining the option of partial bypassing of excess flow (see Figure 6-1).

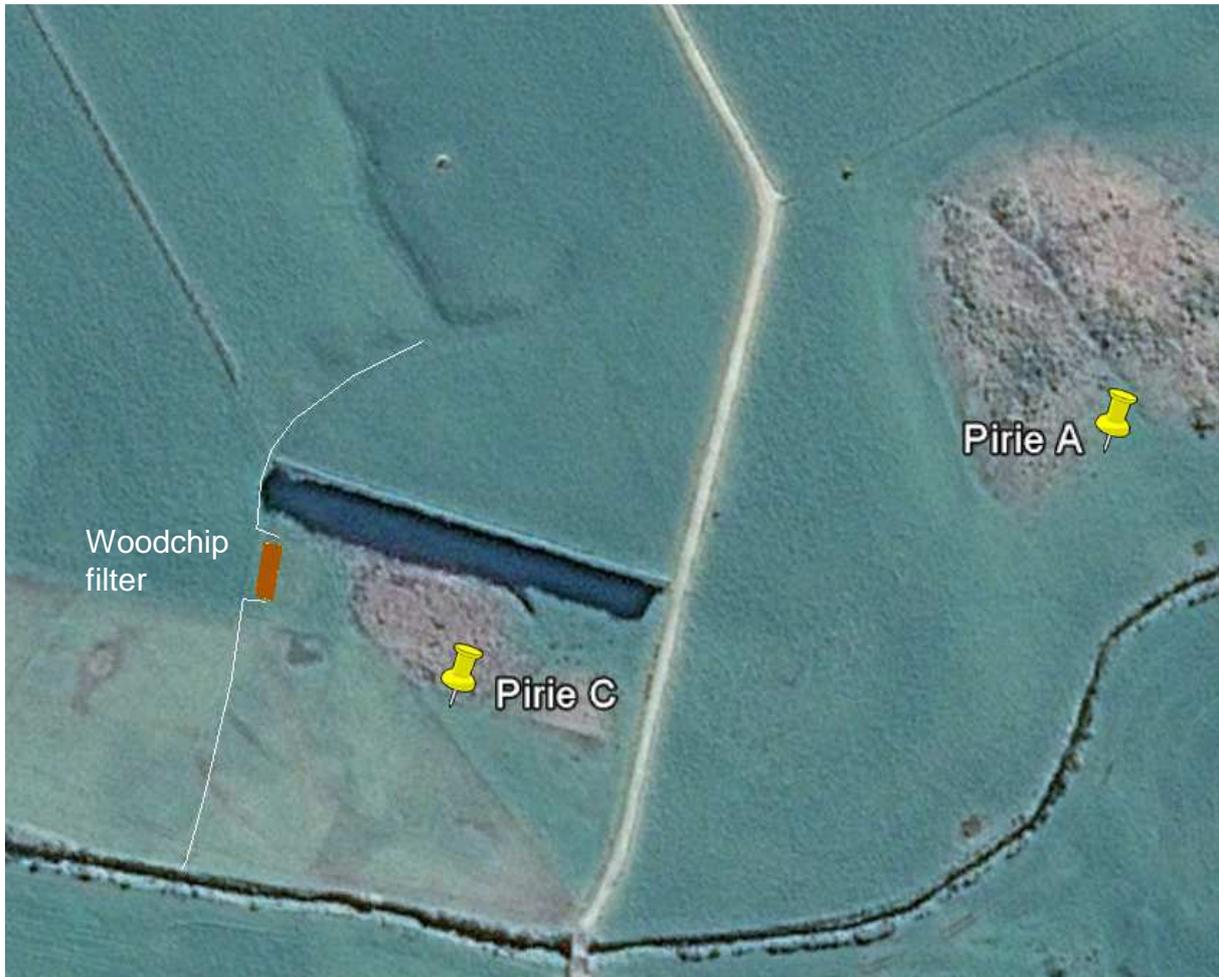
**Figure 6-2: Proposed woodchip denitrification filter trial site Pirie C.** Filter dimensions 5 m by 21 m x 1 m deep (105 m<sup>3</sup>) receiving subsurface drainage from a 9 ha catchment.

A site identified on the Pirie Farm (Pirie C; Figure 6-2) was investigated and deemed suitable for a denitrification filter demonstration trial. The basic layout for the proposed denitrification filter is shown in Figure 6-2. Before going ahead with construction of the filter at this site further monitoring is recommended to ensure that this drain is in fact a significant source of N export. A preliminary costing of ~ \$7.3 K was estimated for construction of the denitrification filter excluding the cost of purchase and transport of suitable wood-chip media for the proposed 105 m<sup>3</sup> filter, which would treat subsurface drainage from a ~9 ha catchment. Based on our preliminary estimate of \$100/m<sup>3</sup> for supply of woodchip material to the site this would add \$10.5K to the cost, increasing the implementation cost to ~\$17.8K or \$1,978 per ha of catchment mitigated.

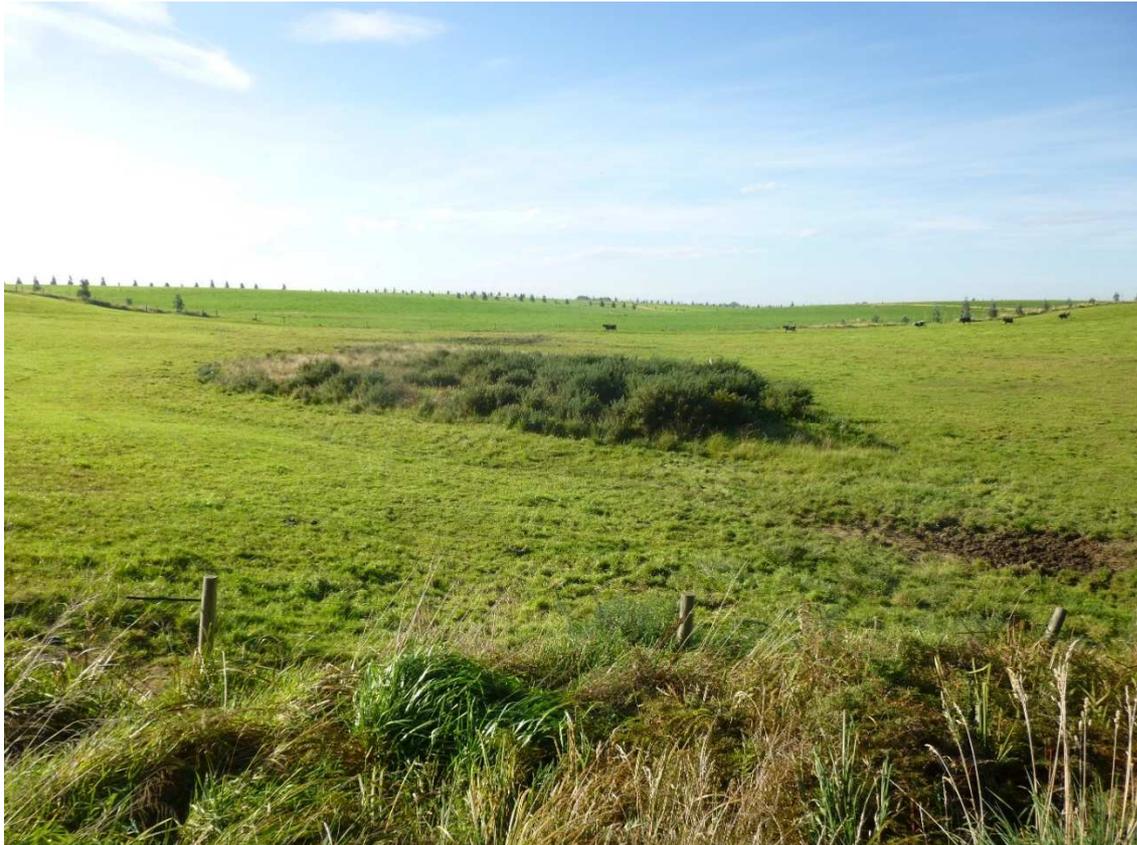
Figure A-2: Potential wetland location on farm site 22b.

The catchment above the wetland area was ~80 ha. A bund across the valley would be required to form a wetland. Agricultural contractor frequently used by Environment Southland, Joe Chisholm, suggested costs to excavate/reform a wetland here in the order of ~\$130K, with a proviso in all instances that this is a very preliminary estimate, and requires on site assessment and test pits dug to give a more definite price.

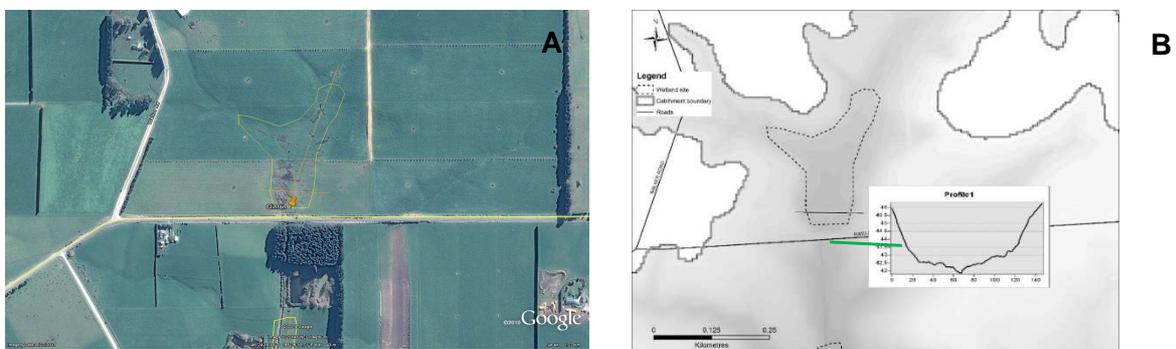
Figure A-3: Site 22b. A. Satellite photo of site. B. LiDAR contours and cross-section. Potential bund shown in green with cross-section of contours shown.

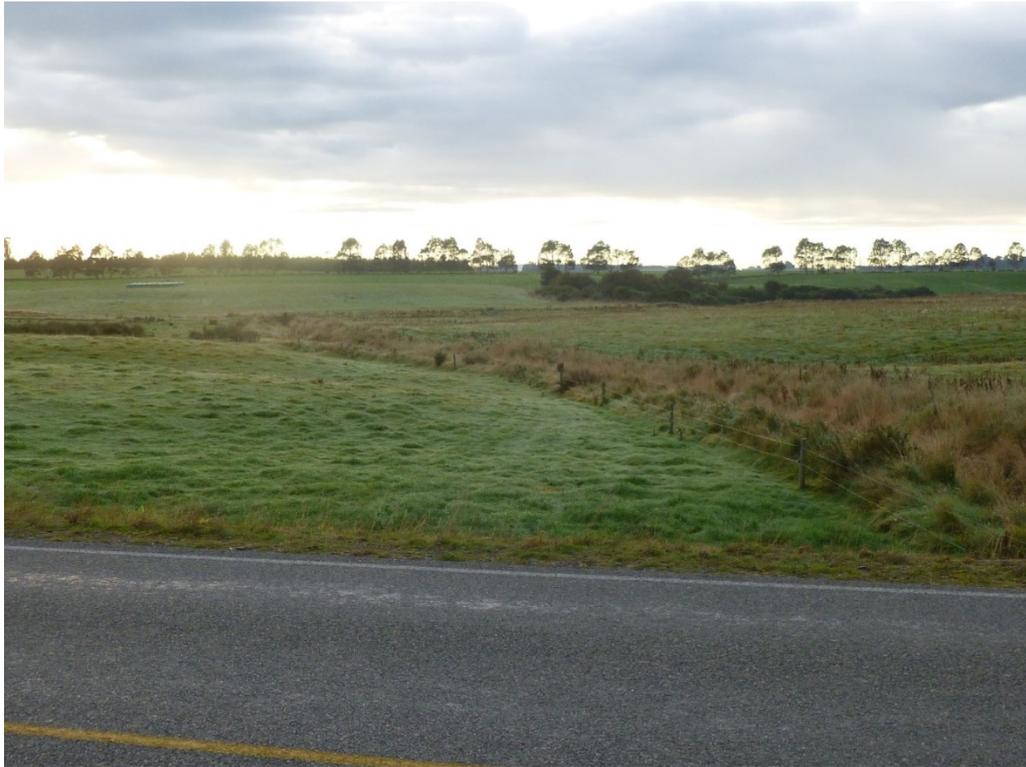
Site 13 (100m N of Mokotua Garage) has a large area of scrubby land which could potentially be utilised as a wetland (at the time of the visit, the potential value of this was not as apparent, so no photos directly of the site). Potential for south and north drains emerging from catchments on other side of the road to be routed into this area. Likely to require a mix of bunding and excavation. Careful on-site assessment will be required.

**Figure A-4: Looking west from road. Main drain emerging from culvert under road, with potential wetland area 13 just visible on the far left of the photo.**

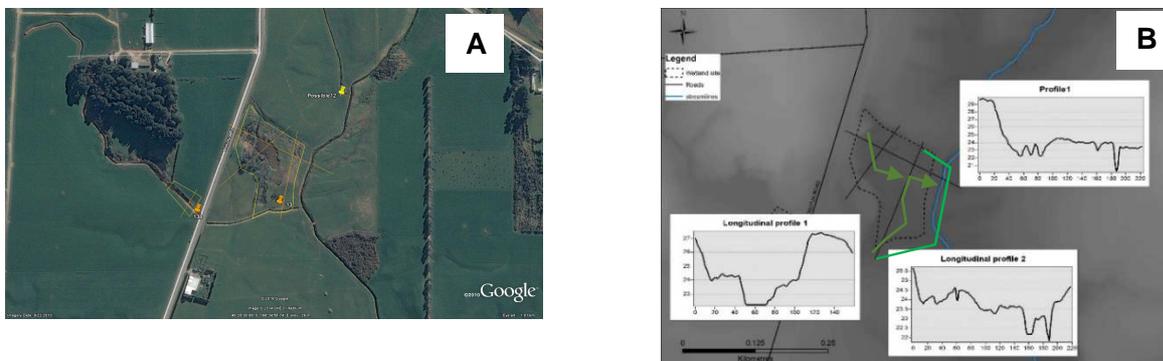
**Figure A-5: A. Satellite photo of site. B. LiDAR contours.** Potential wetland shown with dashed line, and bund shown in green. Flow paths shown in orange. The distance along Longitudinal profile 2 (from wetland border area to wetland border area).

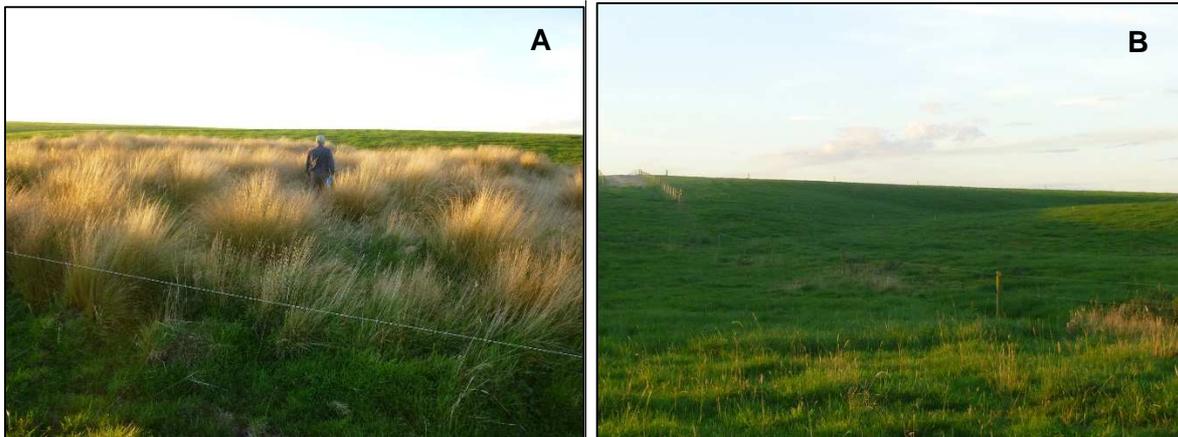
The patches of red tussock are mostly “toe-slope” seepage areas with little potential for further development. A potential area for a wetland was a valley swale coming down between remnant red tussock patches. This was a reasonably well-developed pasture area, so may not be ideal from farmer point of view. However its small size and facilitative landscape features would potentially provide a good site for cost-effective small-scale trial. Note, historical Google Earth imagery shows a small pond/dam which is no longer present. The tussock patches are remnants which at times appear to have undergone significant periods of grazing as they appear absent from some past images.

Wetland could be created by 1-2 m high dam across mouth of swale and partial excavation further up into valley.

**Figure A-7: A. Red tussock site. B. view looking up swale which is a potential wetland impoundment site.**

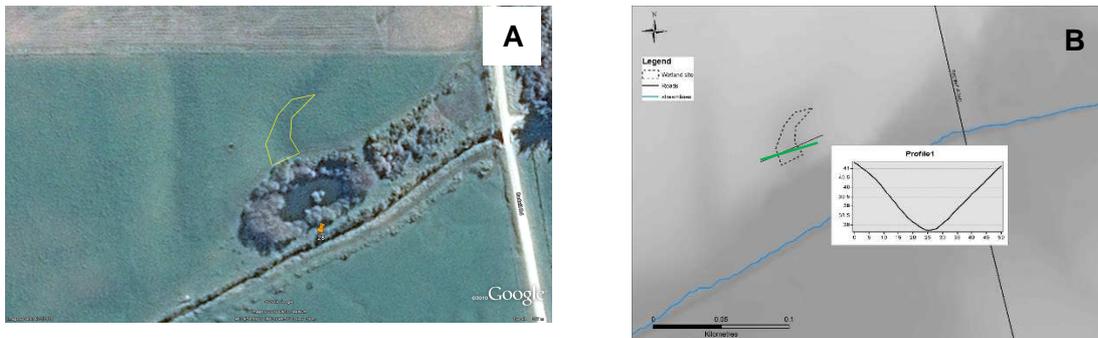
**Figure A-8: A. Satellite photo of site. B. LiDAR contours. Potential bund shown in green. Bund may need to be >2.5m.**

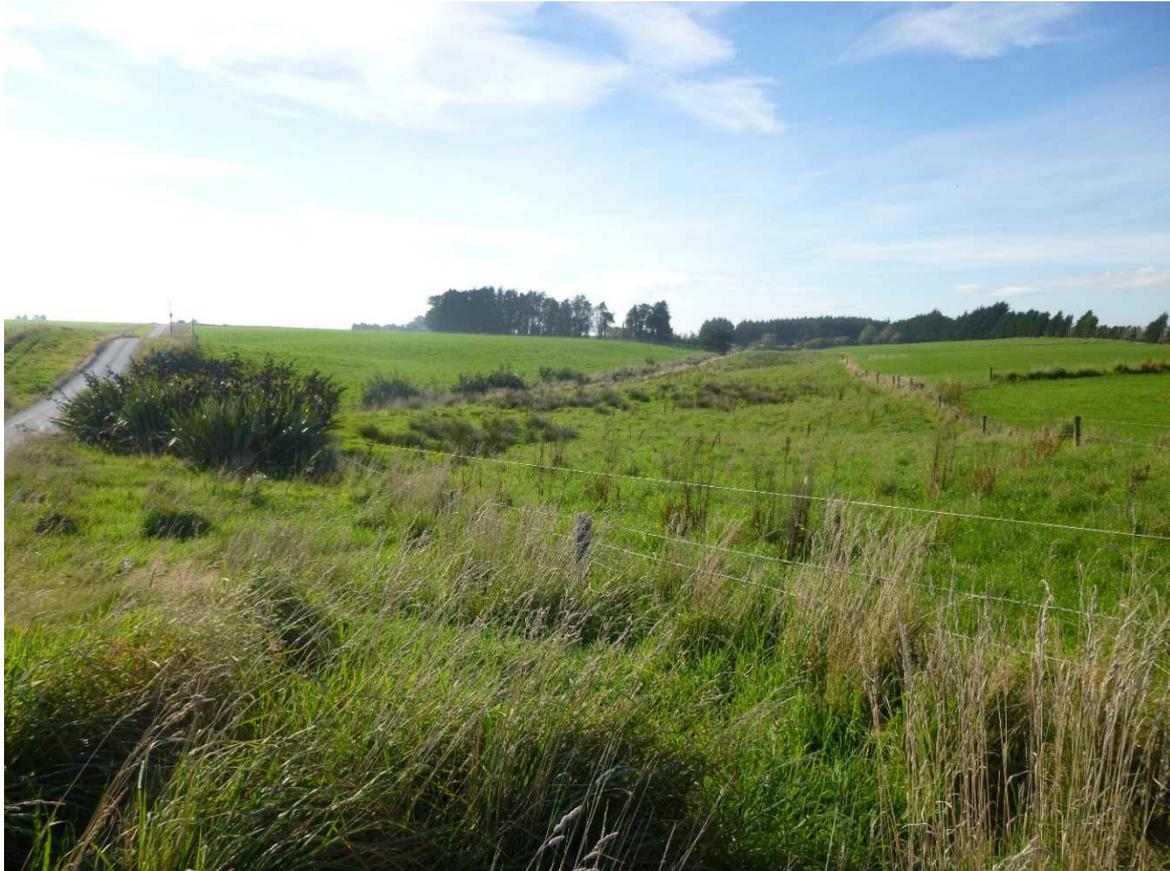
Long straight surface drain (maintained by ES) with side swales (with subsurface drains), sited inside a fence along the drain. Paddock on true left side quite rough, less so on other side. Potential lower bund shown in green and proposed wetland area shown by dashed line. Likely to require 2-3 bunds and significant excavation on either side to form shallow wetland and allow for unimpeded drainage from side drains and along main drain.

Joe Chisholm estimated ~\$130K to build such a wetland at this site.

**Figure A-9: Site 21 looking upstream from Drakes Hill Rd. Potential wetland location shown along stream banks.**

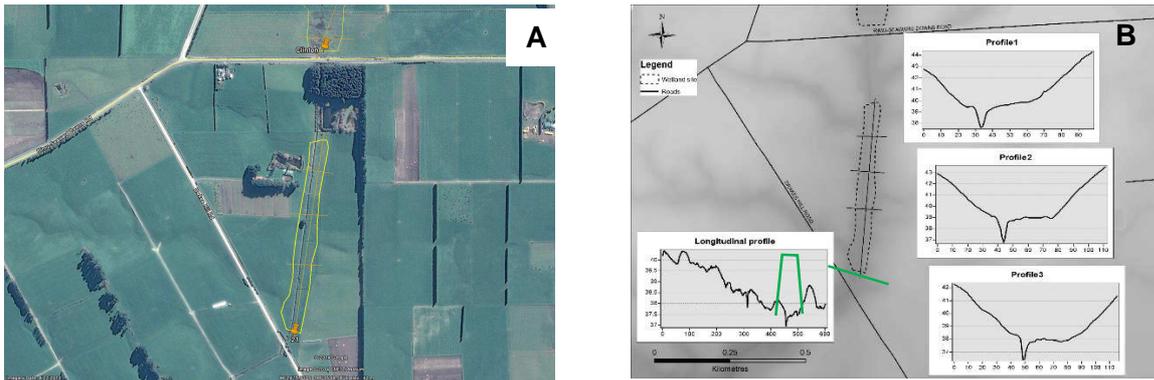
**Figure A-10: Site 21 A. Satellite photo of site. B. LiDAR contours and cross-sections. Potential bund shown in green.**

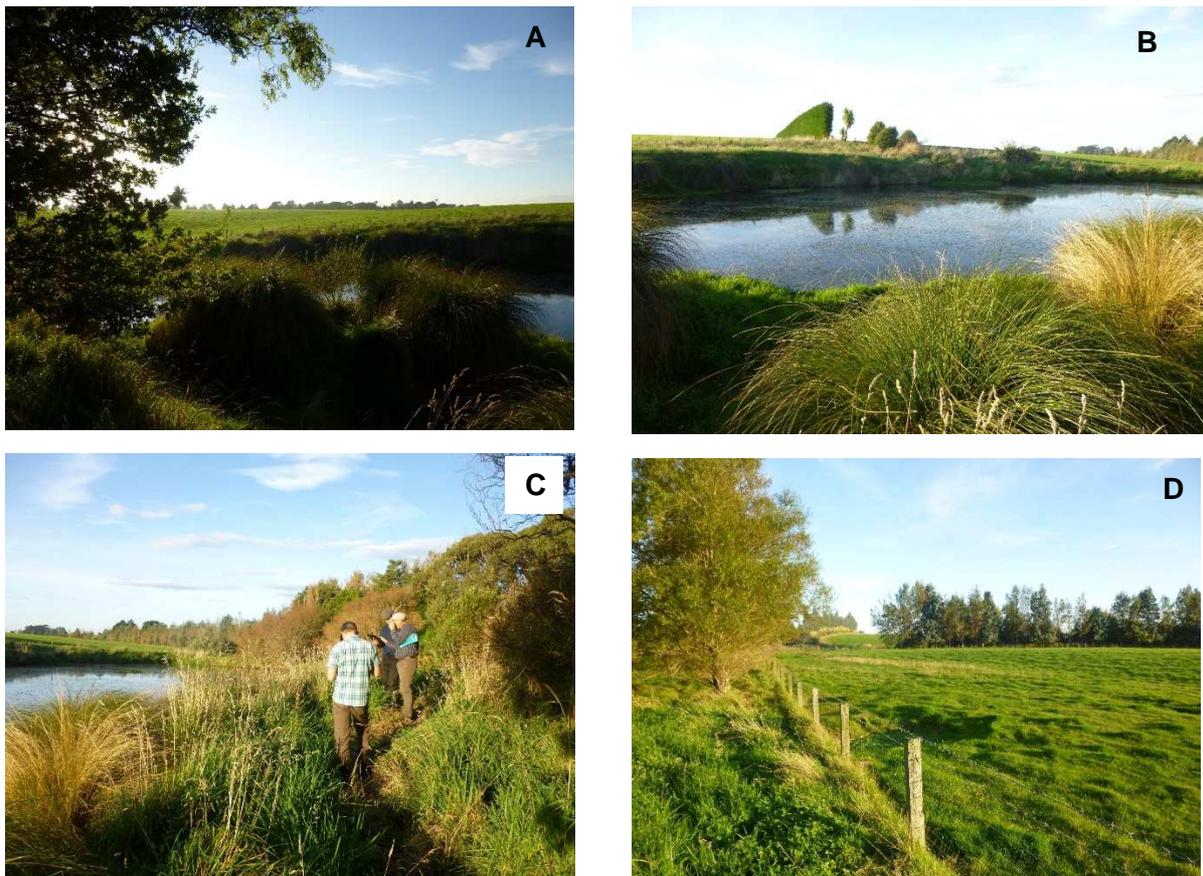
Duck Pond on Botting Farm, which appears to be perched above and not connected to surface drain inflows. Uncertain where flow into pond is coming from. Likely tile drains extend down adjacent valley beside pond area and discharges to Waituna Creek. Ideally wetland intercepting this drain would need to be twice the size indicated in Figure A-12 A to provide the desired wetland to catchment ratio. Would require significant excavation down to intercept tile and form wetland that does not impede drainage of surrounding land. May require 2 tier wetland up into valley. There is only potential to treat the first arm, but pond may be doing reasonable job anyway, if it is connected with the main flow.

**Figure A-11: Site 4 photos.** A-C. Pond and surrounds. D. Potential wetland area.

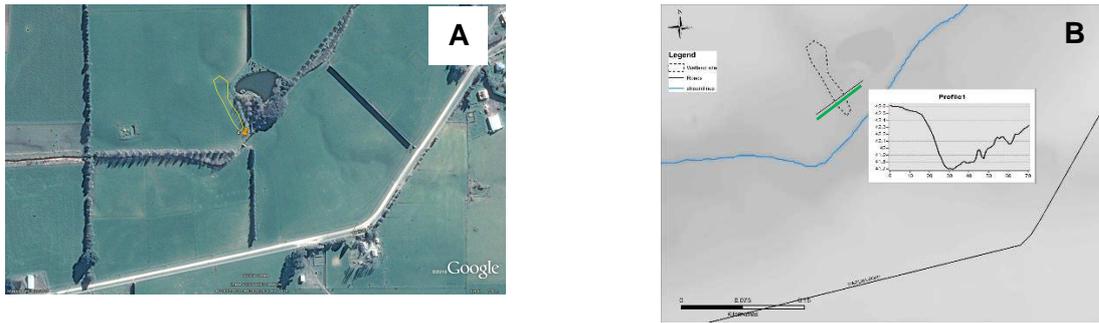
**Figure A-12: Site 4. A. Satellite photo of potential wetland site. B. LiDAR contours. Potential bund shown in green.**

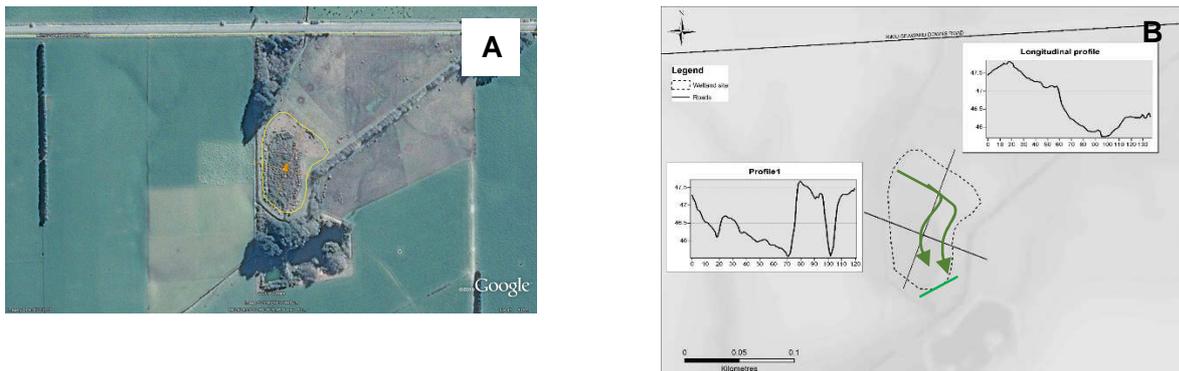
**Figure A-13: Site 4. A. Satellite photo of potential wetland site. B. LiDAR contours. Potential bund site shown in green. Excavation of site would be required to induce flow distribution with sinuous path as shown in orange.**

Site 6 had a catchment of ~187 ha. The site included an old gravel pit. The stream has two major arms that connect immediately below pit. Upstream N loads appear low. Some recent drainage work was apparent. Ability to direct flows from drain into pit area would require more extensive excavation than at present as pit not down into groundwater.

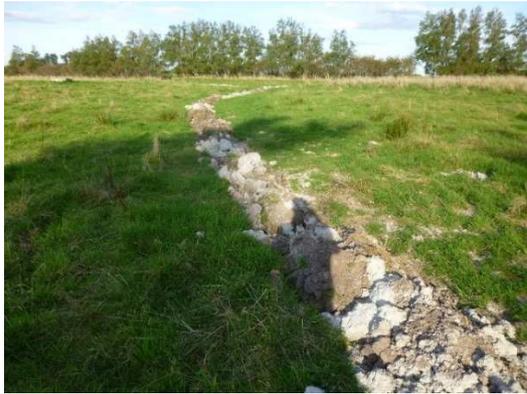
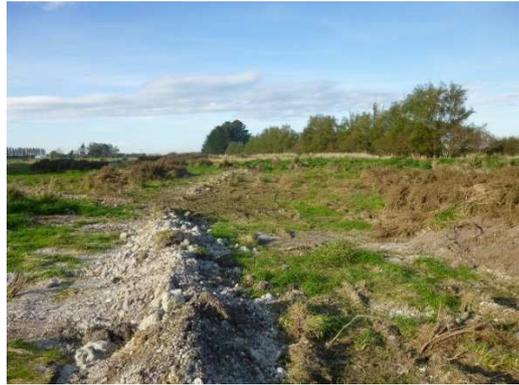
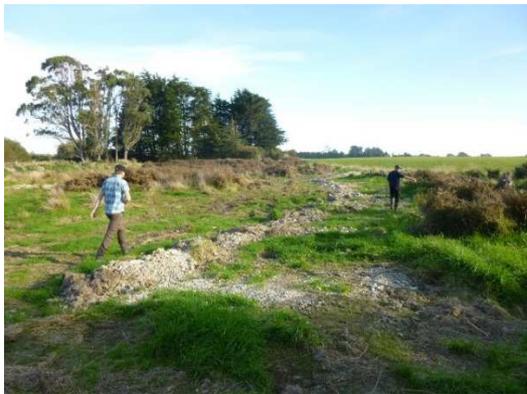
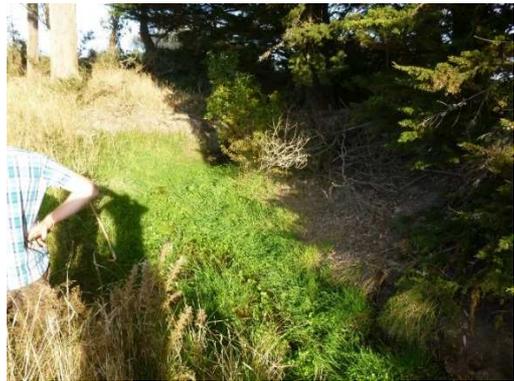
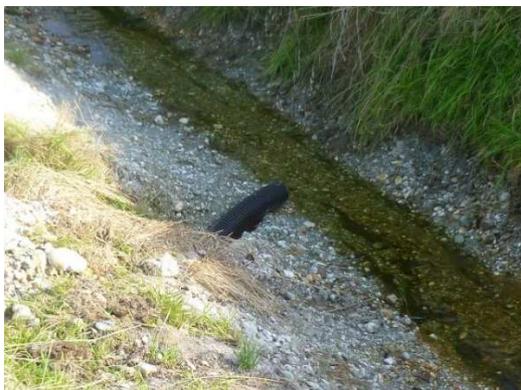
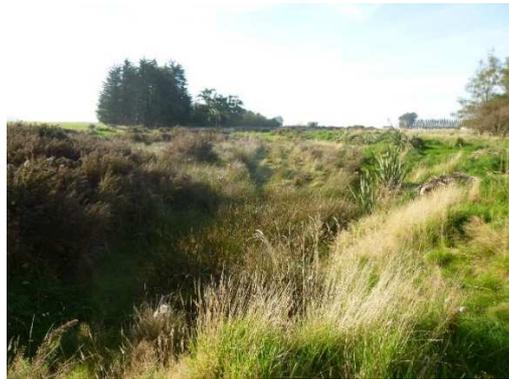
**Figure A-14: Site 6 photos.** Showing stream along edge of site, recent subsurface drain installation and general site layout.

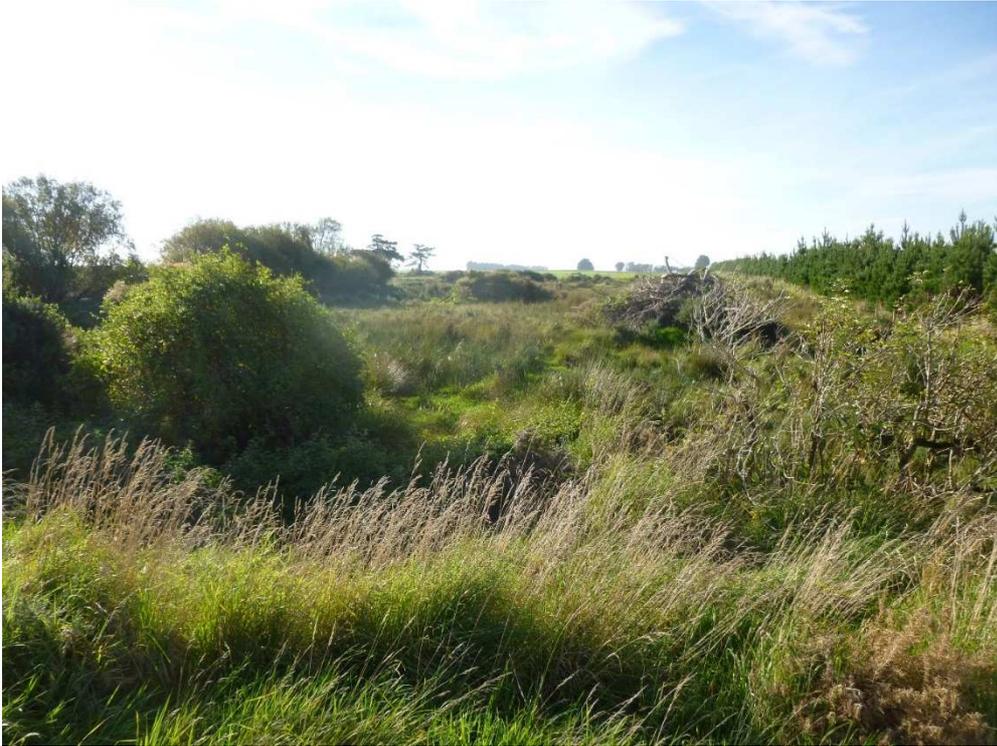
Unsure of owner. Scrub area identified by James Dare. Seems to be a pond there. The area to the left of the photo (Figure A-15) which contains a pond (Figure A-16) appears perched above the stream level and thus not suitable to link this as a pond/wetland.

Figure A-15: Photo of Site 26 showing scrub area alongside stream.

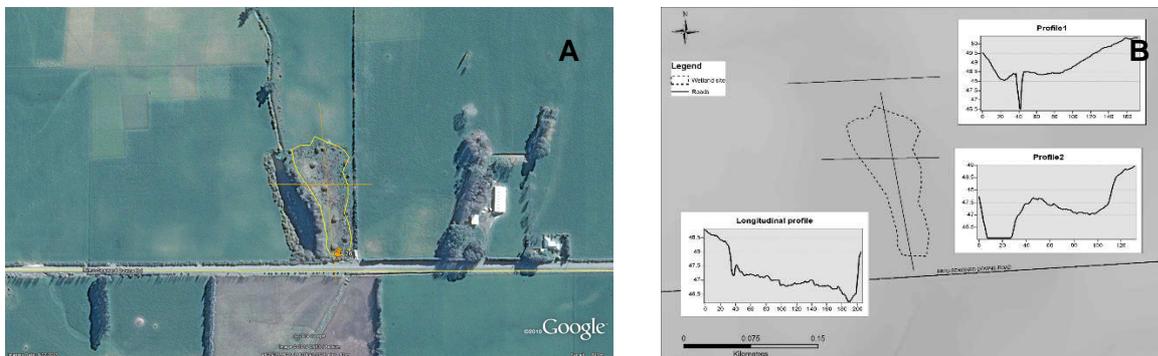
Figure A-16: Site 26 A. Satellite image of potential site. B. LiDAR contours and cross-sections.

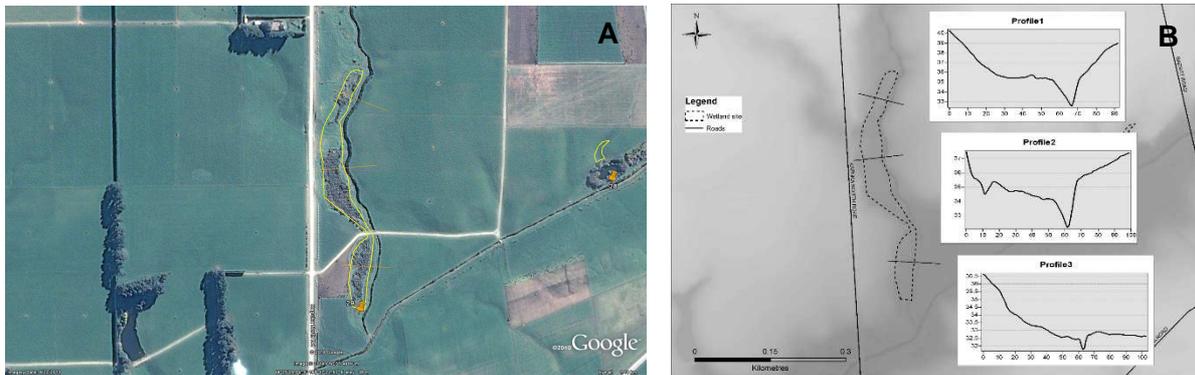
**Figure A-17: Site 29. A. Satellite image of potential site. B. LiDAR contours and cross-sections.** Toe-slope wetland areas alongside stream.

This site was not directly viewed. Like the tussock sites at Site 28, these appear to be toe-slope seepage areas, and thus not easy to impound. As can be seen from the profiles below, any bund would need to pass along the eastern edge (distance >460 m) of the wet areas and then up the sides. They may still be performing a useful nutrient control function for the water passing through them.

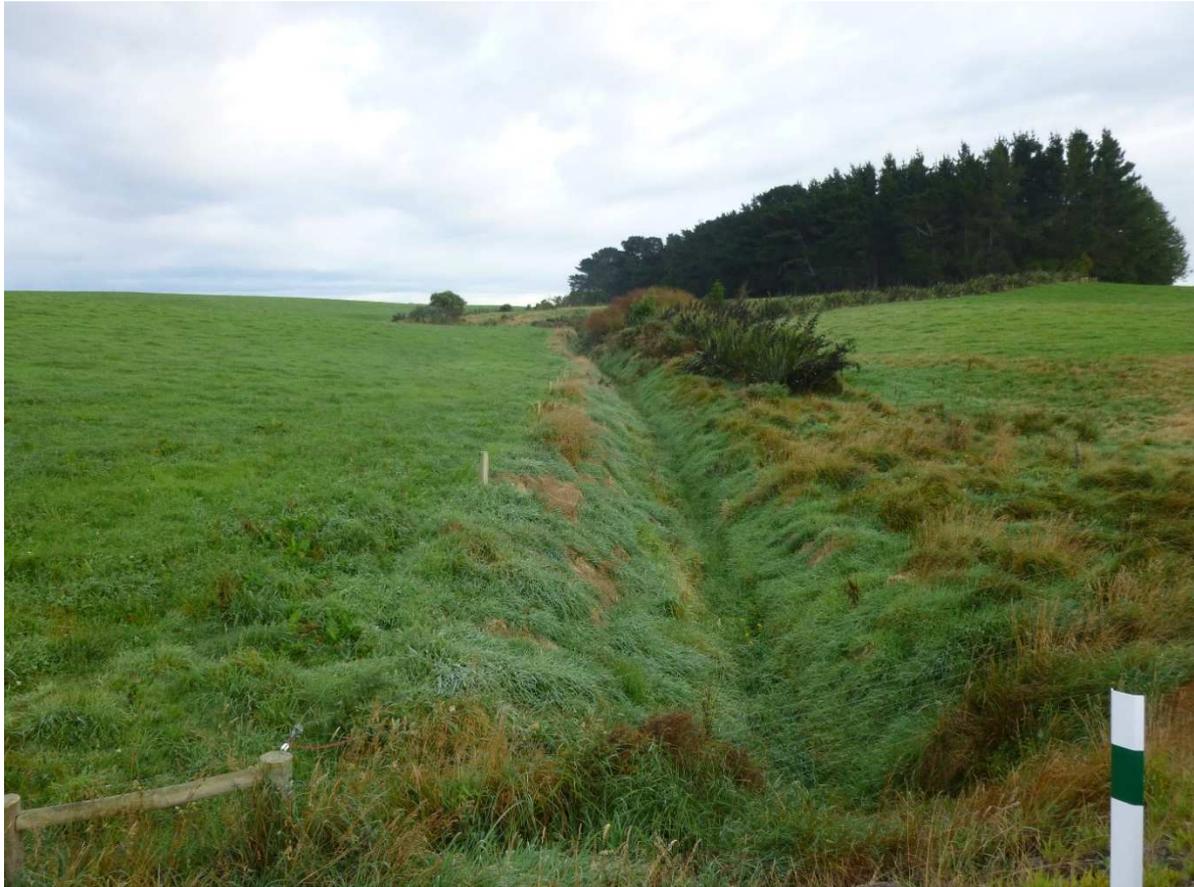
This site is across the road from Site 13. Slope is better with less apparent unintentionally affected areas of drainage. The catchment on this site is much larger than was apparent at the time of the visit, thus any single wetland will be too small. A series of smaller wetlands may be an acceptable solution, but would require up to 3 bunds.

**Figure A-18: Photo of Site 13b looking upstream.**

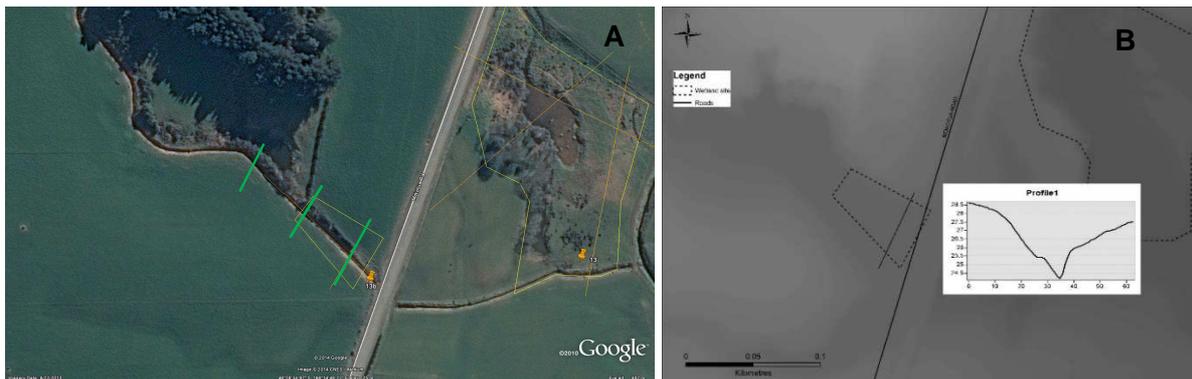
**Figure A-19: Site 13b. A. Satellite image of potential CW site. B. LiDAR contours and cross-sections. Note potential bund sites.**
