## Constructed Wetland Options in the Upper Waituna Catchment

Prepared for Dairy NZ

June 2014

NIWA Client Report No: HAM2014-069  
Report date: June 2014  
NIWA Project: DNZ14207

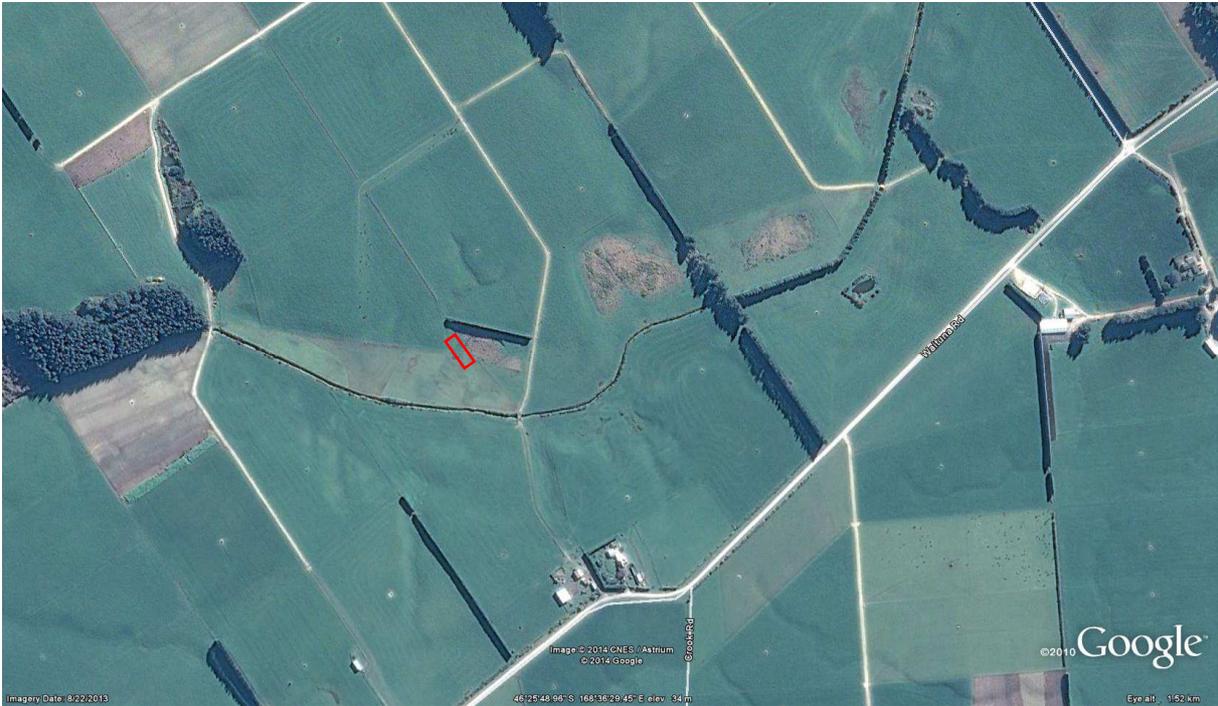
Potential site for woodchip denitrification filter.

**Figure A-22: Satellite image of potential denitrification site.** Red rectangle denotes potential site.

A site identified on the Pirie Farm (Pirie C; Figure 6-2) was investigated and deemed suitable for a denitrification filter demonstration trial. The basic layout for the proposed denitrification filter is shown in Figure 6-2. Before going ahead with construction of the filter at this site further monitoring is recommended to ensure that this drain is in fact a significant source of N export. A preliminary costing of ~ \$7.3 K was estimated for construction of the denitrification filter excluding the cost of purchase and transport of suitable wood-chip media for the proposed 105 m<sup>3</sup> filter, which would treat subsurface drainage from a ~9 ha catchment. Based on our preliminary estimate of \$100/m<sup>3</sup> for supply of woodchip material to the site this would add \$10.5K to the cost, increasing the implementation cost to ~\$17.8K or \$1,978 per ha of catchment mitigated.

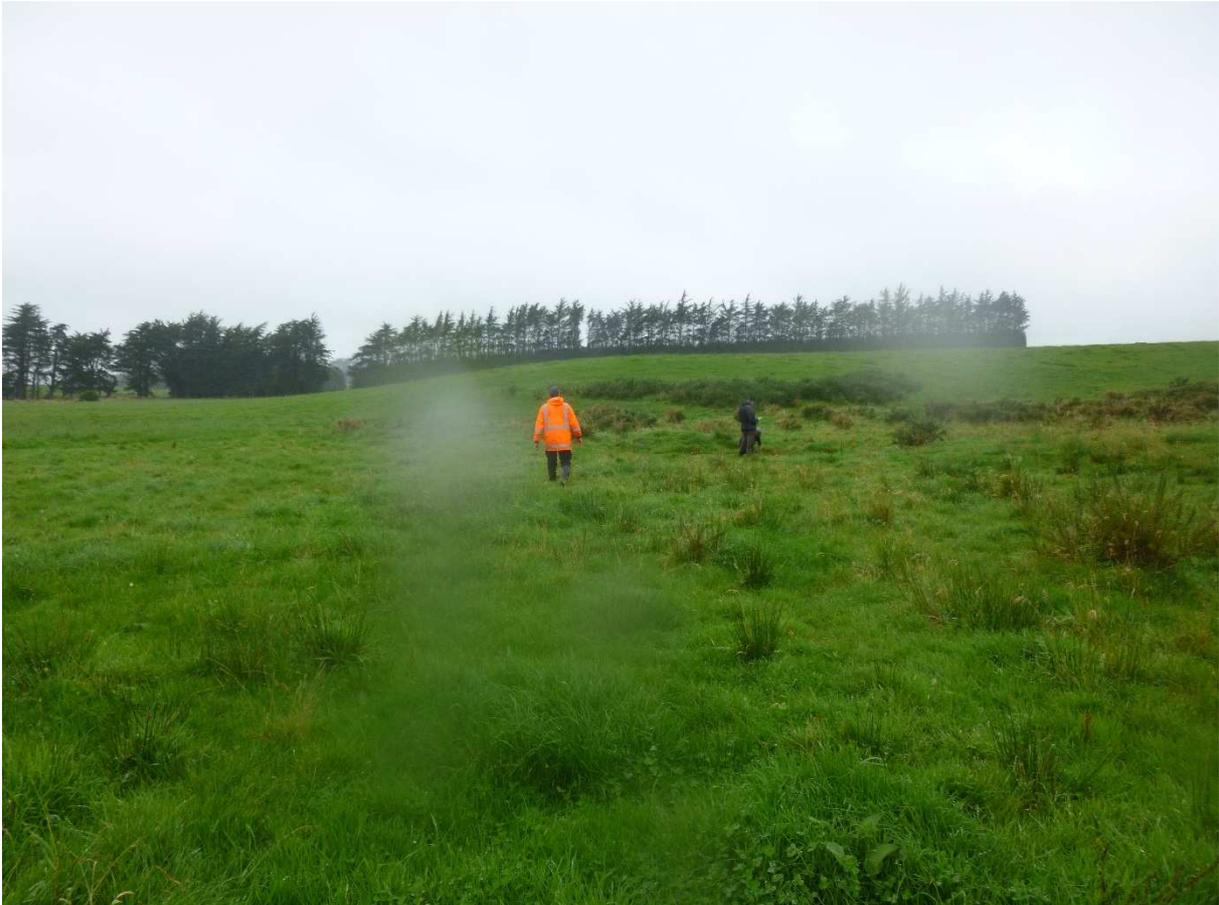
Figure A-23: Potential denitrification filter site.

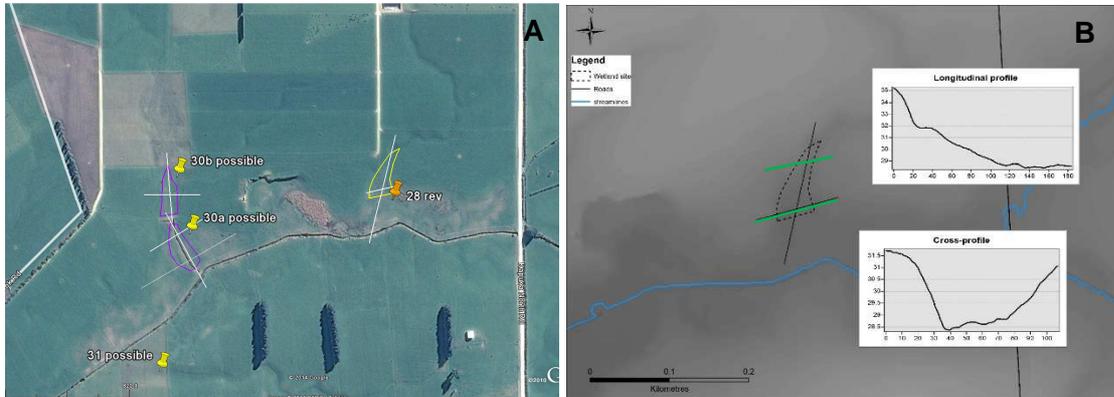
**Figure B-2: A. Google Earth image of site 28 in August 2013. B. LiDAR contours and cross-sections.** Potential bunds shown in green and proposed wetland area shown by dashed line.

The initial site investigated has had further LiDAR contours added, and additional potential sites added. These were not investigated during our visit in April and are marked to the west.

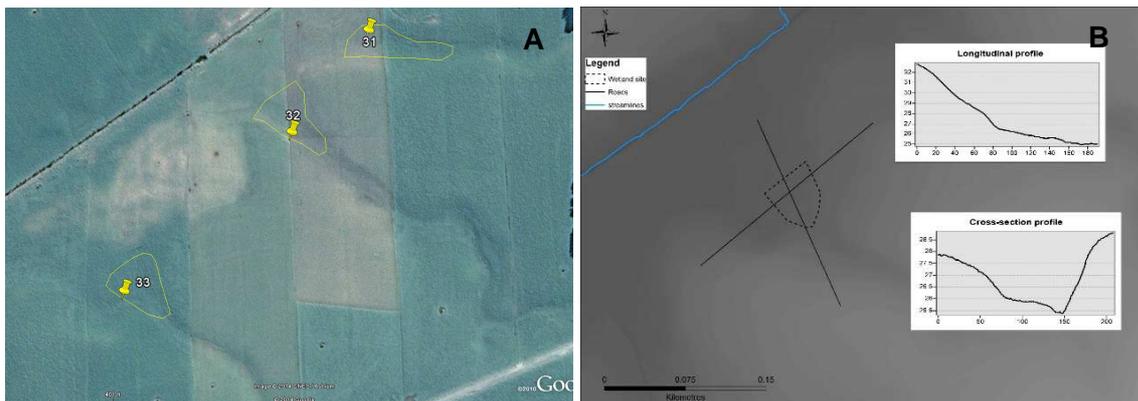
**Figure B-3: Sites 31-33 showing potential wetland areas at the end of swale valleys. B. LiDAR contours and cross-sections.**

Further investigation of this site is warranted.

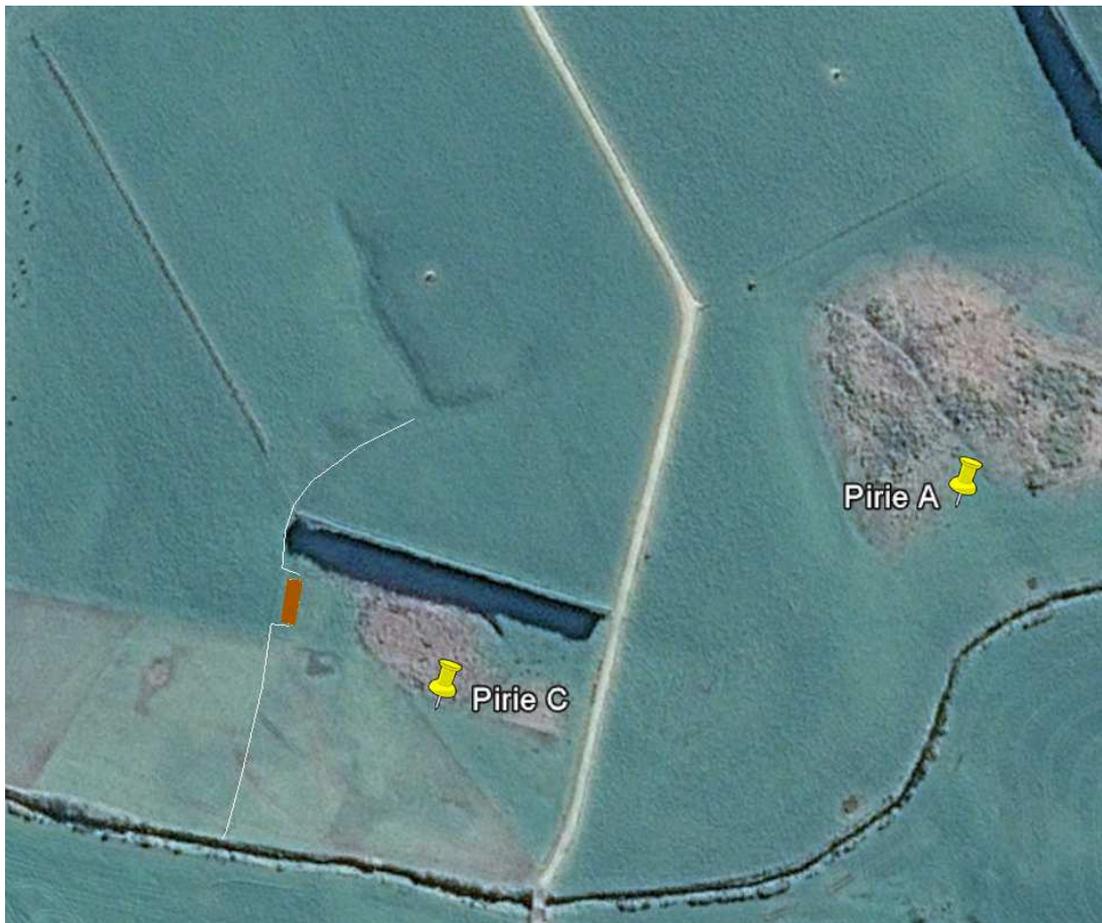
**Figure B-4: Potential site for wood-chip filter on Pirie Farm.** Subsurface drain flow to be diverted via weir into filter and then returned to drain at exit. High flow bypass via drain to be maintained.

Potential site for woodchip filter intercepting subsurface drain flow. Propose woodchip material in filter to be 1 m deep (saturated), lined and covered with good quality liner material with water-tight pipe connections (to enable accurate monitoring), and 5 m wide by 21 m long (105 m<sup>2</sup> in area).

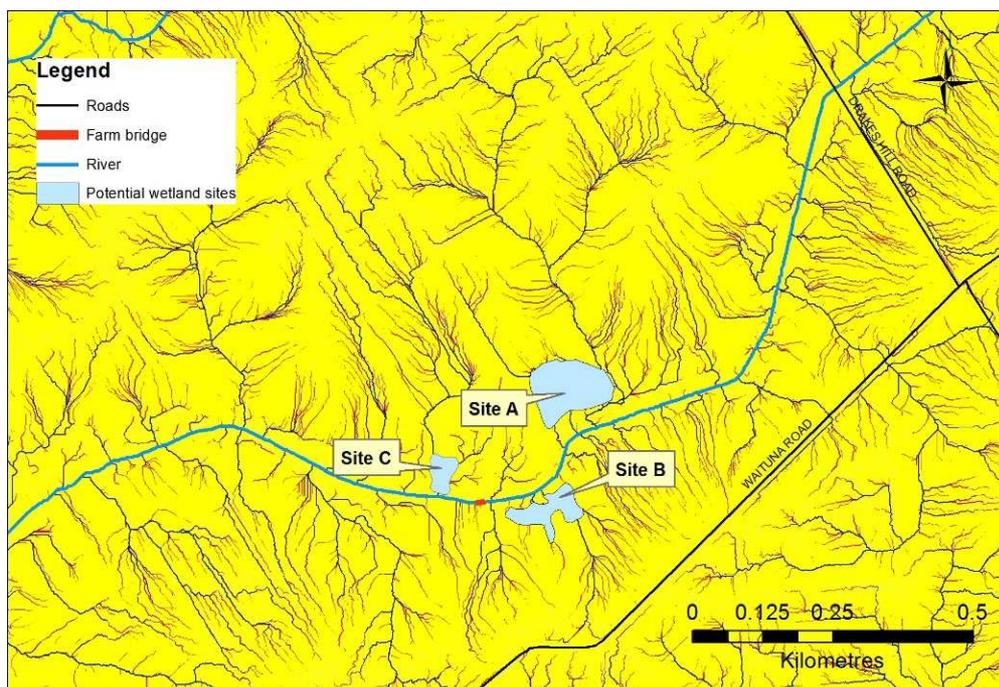
**Figure B-5: Pirie farm potential contributing catchments for site A-C.** The detailed drainage network (obtained from LiDAR data) illustrates the approximate areas that drain into the wetland sites.

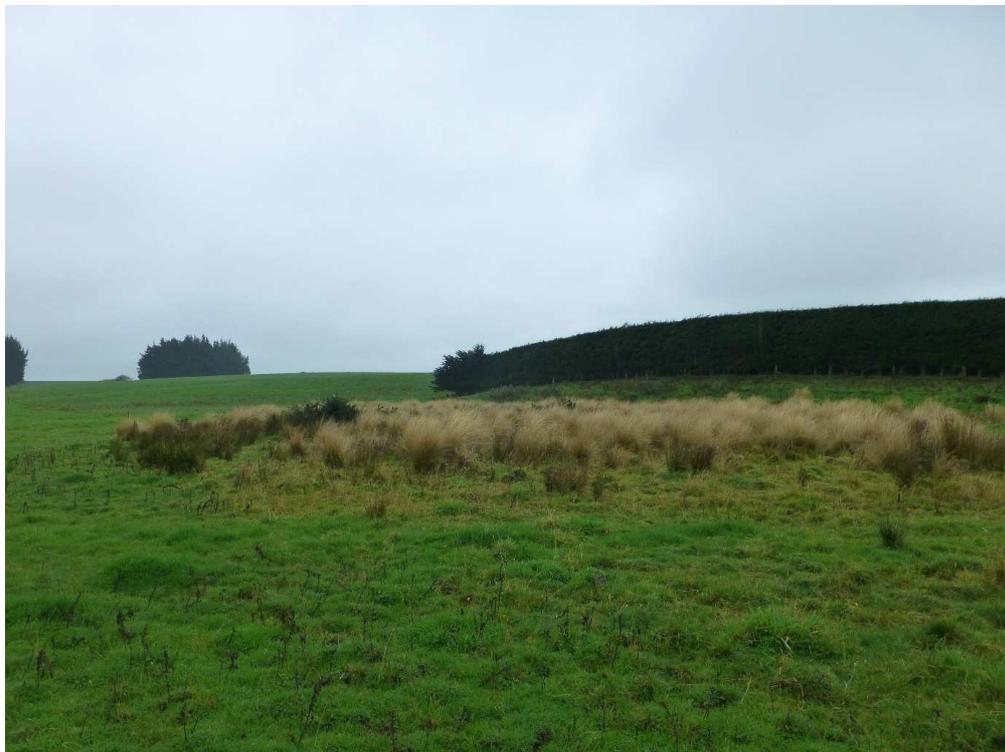
**Figure B-6: View towards Pirie C site.** Subsurface drain emerges at left end of hedge. In foreground poorly drained remnant *Sphagnum* peat bog. Proposed to site woodchip filter between drain and peat bog area.

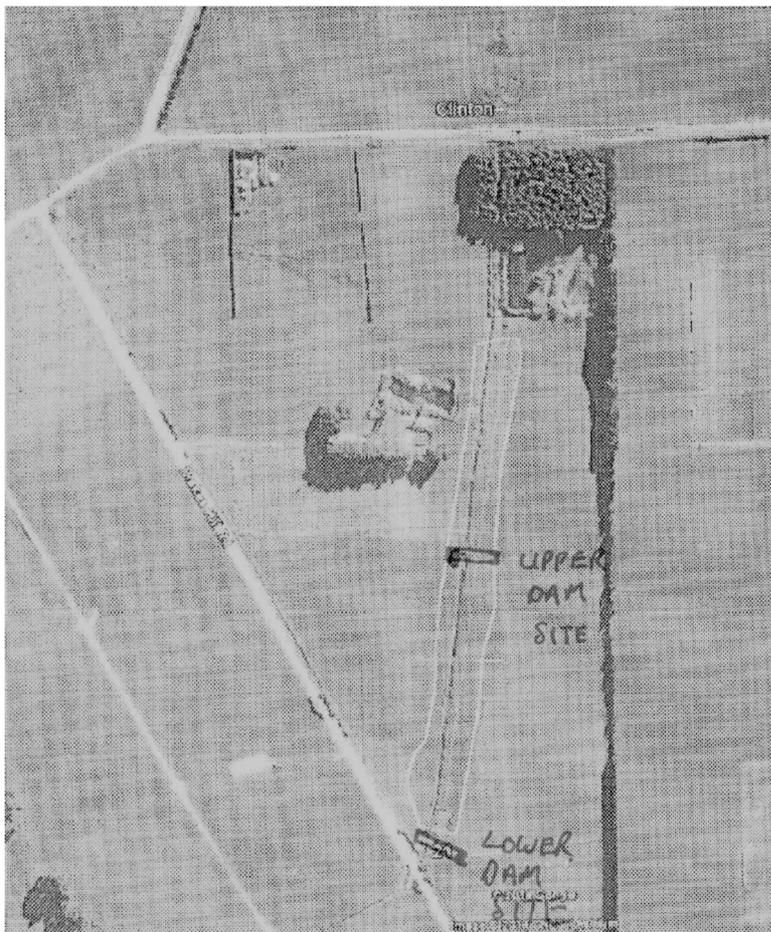
**Figure D-1: Conceptual plan for wetland construction at site 21.** Location of two proposed dams and general extent of wetland shown.
