Hauraki Plains clay pond case study

Can I build a pond in Hauraki marine clay without a liner?

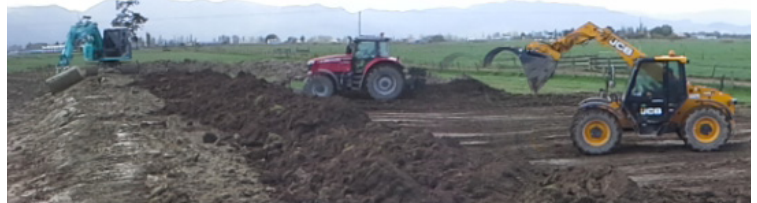
The pond construction was essentially a 'cut to fill' operation with set compaction criteria to be met for the bund fill. In this case the farmer had many pieces of the plant required for the job and only had to hire a sheepsfoot roller to compact the clay. The following plant was used:

- 1 x 16 tonne excavator with ditch bucket
- 2 x tractors with trailers
- 1 x 8 tonne sheepsfoot roller
- 1 x 12 tonne tractor with spreader bar.

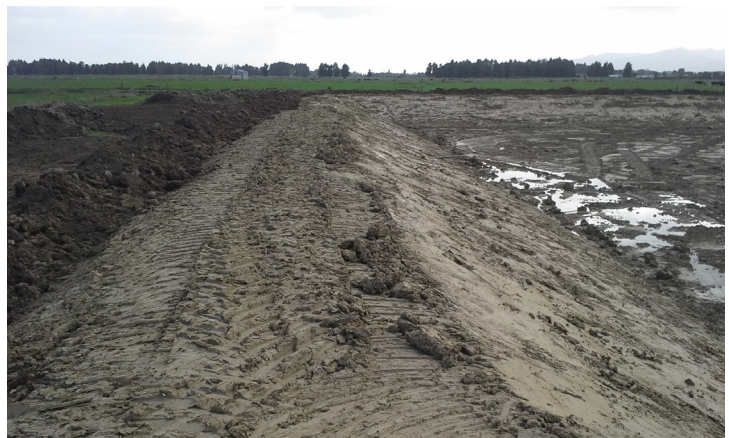
After stripping topsoil to a stockpile, a compaction trial was carried out. The results of this set the compaction method for the rest of the earthworks. Soil density and air voids were measured using a nuclear densometer. A shear vane was also used and calibrated to the soil's moisture content, density and shear strength, as well as checking the change in soil shear strength with increasing compaction effort. The excavator dug the material and placed it into the trailers. The tractors then carried the fill around the footprint of the bunds and placed it in the bunds' location.

The tractor with a spreader bar graded the fill into 200mm layers before the sheepsfoot roller compacted the fill. The engineer and the farmer conferred when layers of clay had been placed and compacted. All layers were inspected visually for consistency of clay material, and shear vane readings made. Similarly, the sides and base of the excavation were monitored for unacceptable layers of sand, shells, or peat. To finish the pond, the bund slopes were trimmed to the design gradient and the topsoil re-spread in a 200-300mm layer over the bunds. It took 70 hours to complete construction.
